Road issues in Bon Street, Alexandra

Ms L Bonazzi
CEO
Murrindindi Shire Council

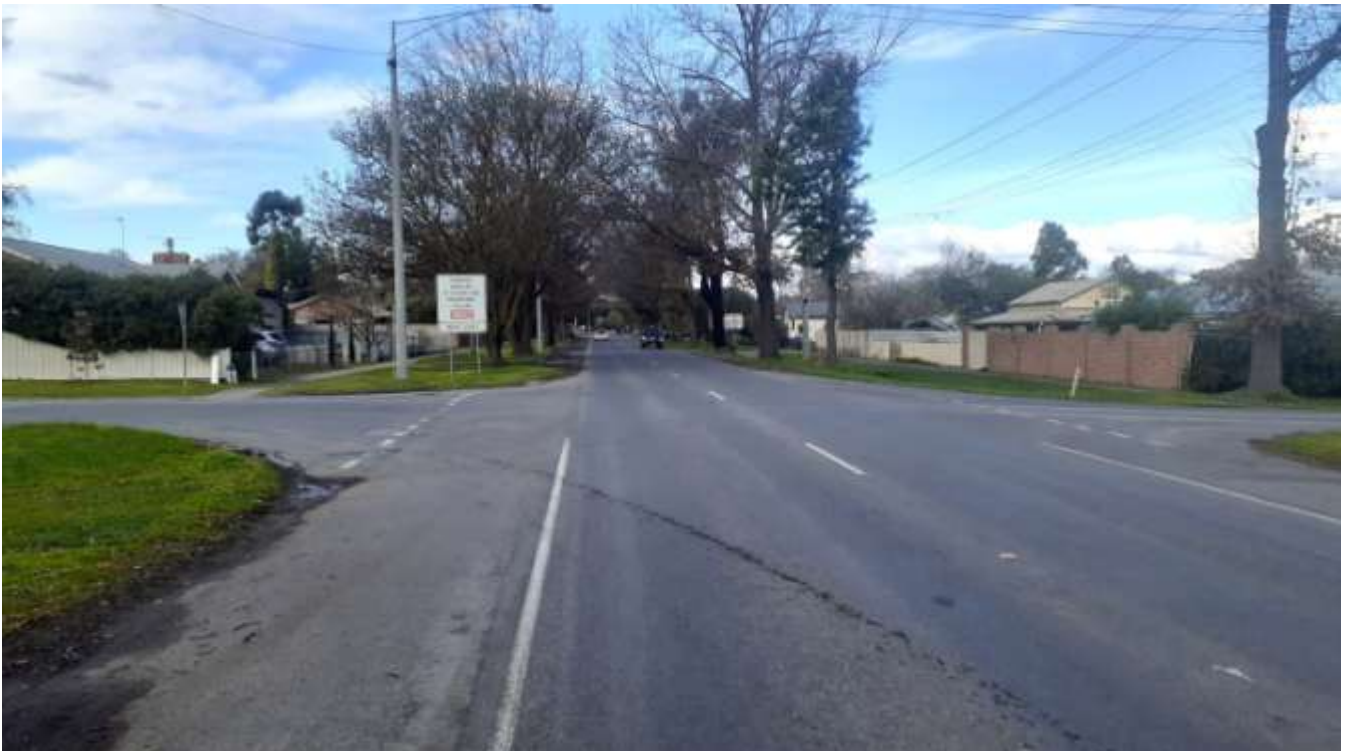
- a. Green, William and Station Streets together form the OD route around the town, however poor siting and deteriorated OD signage could well be the cause of increased traffic along Bon Street. The general belief is that this may be due to motorists missing the OD signage into Green/William Streets and simply choosing the next street which is Bon Street. The OD sign in Aitken Street (Pic 1) directing oversized vehicles often seems to blend with the background of the street and the actual "OD 22" sign is so small that it is entirely possible to miss it.

Pic 1. Aitken Street at Taylor Street looking east.

- Ensuring the roadway width is consistent with normal street specifications. There appears adequate room along the northern side of the street to do this;
- Review of shoulders and kerbing; and
- Improving the OD signage in each direction to the OD route.

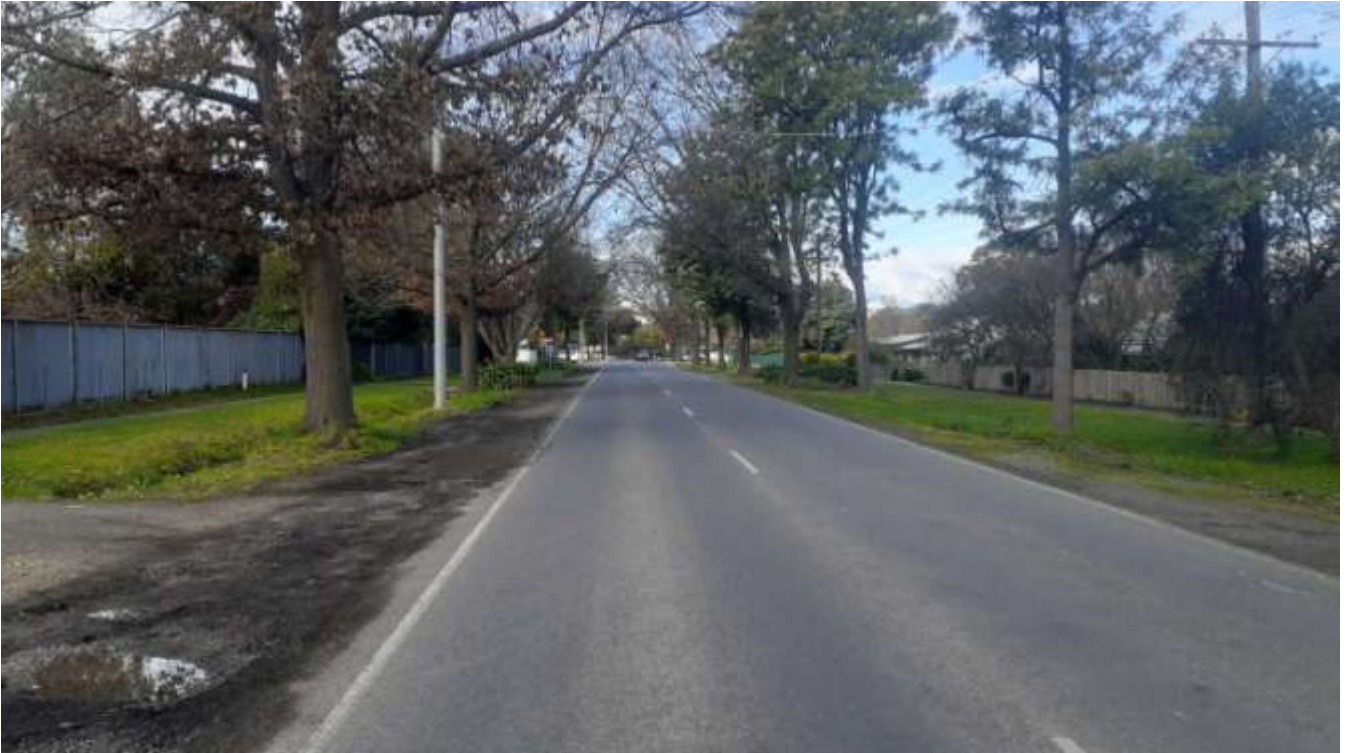
- b. As traffic approaches the OD turnoff into Green Street, the OD signage becomes even harder to see due to the small size (Pics 2 & 3).

Pic 2. Aitken Street approaching Green Street

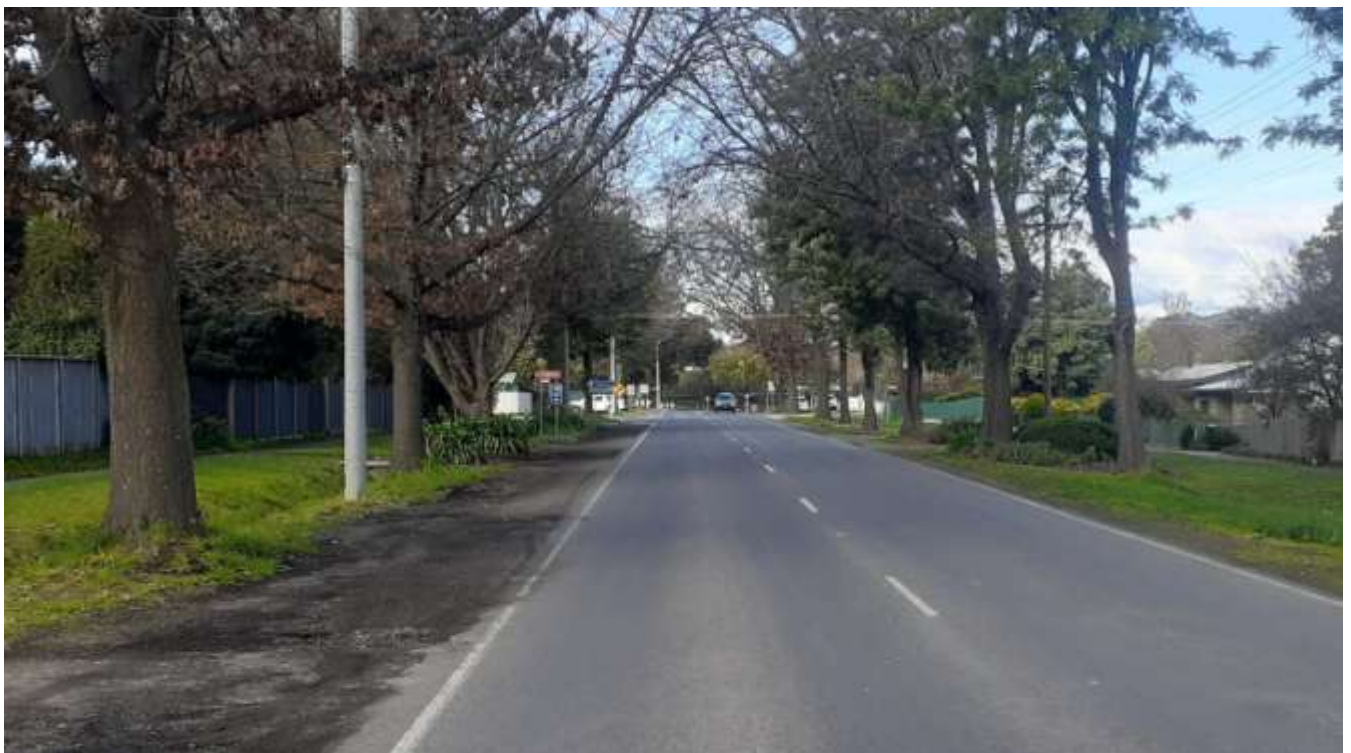
Pic 3. Aitken Street near Green Street

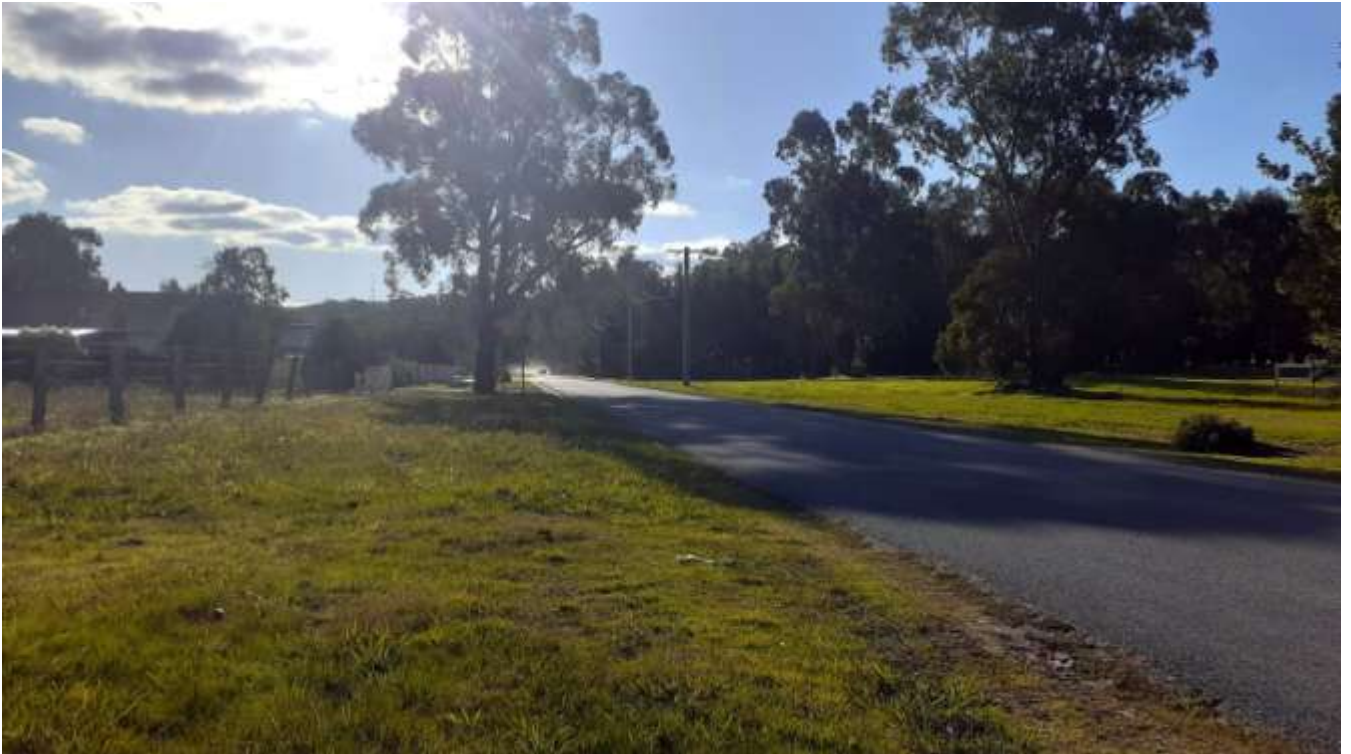
c. The reverse route also has some issues when accessing the OD from the Goulburn Valley Highway. The small OD signage on the Goulburn Valley Highway directs traffic into Station Street which then travels in a northerly, then westerly direction around the town. There are no OD directional signs on Station Street until traffic arrives at William Street (Pic 4), a distance of approximately 1 kilometre. It could be construed that traffic may think the next street (Bon) is in fact the OD route.

Pic 4. Station Street at Bon Street.
