Application for Planning Permit
Extend use of existing Campsite and maintain the existing facilities permanently on site
1059 Maroondah HWY, Narbethong

Proposed extension of use for Campsite at 1059 Maroondah HWY, Narbethong
Property Outline and Management Statement

LAND CAPABILITY ASSESSMENT

Report No L140/2019

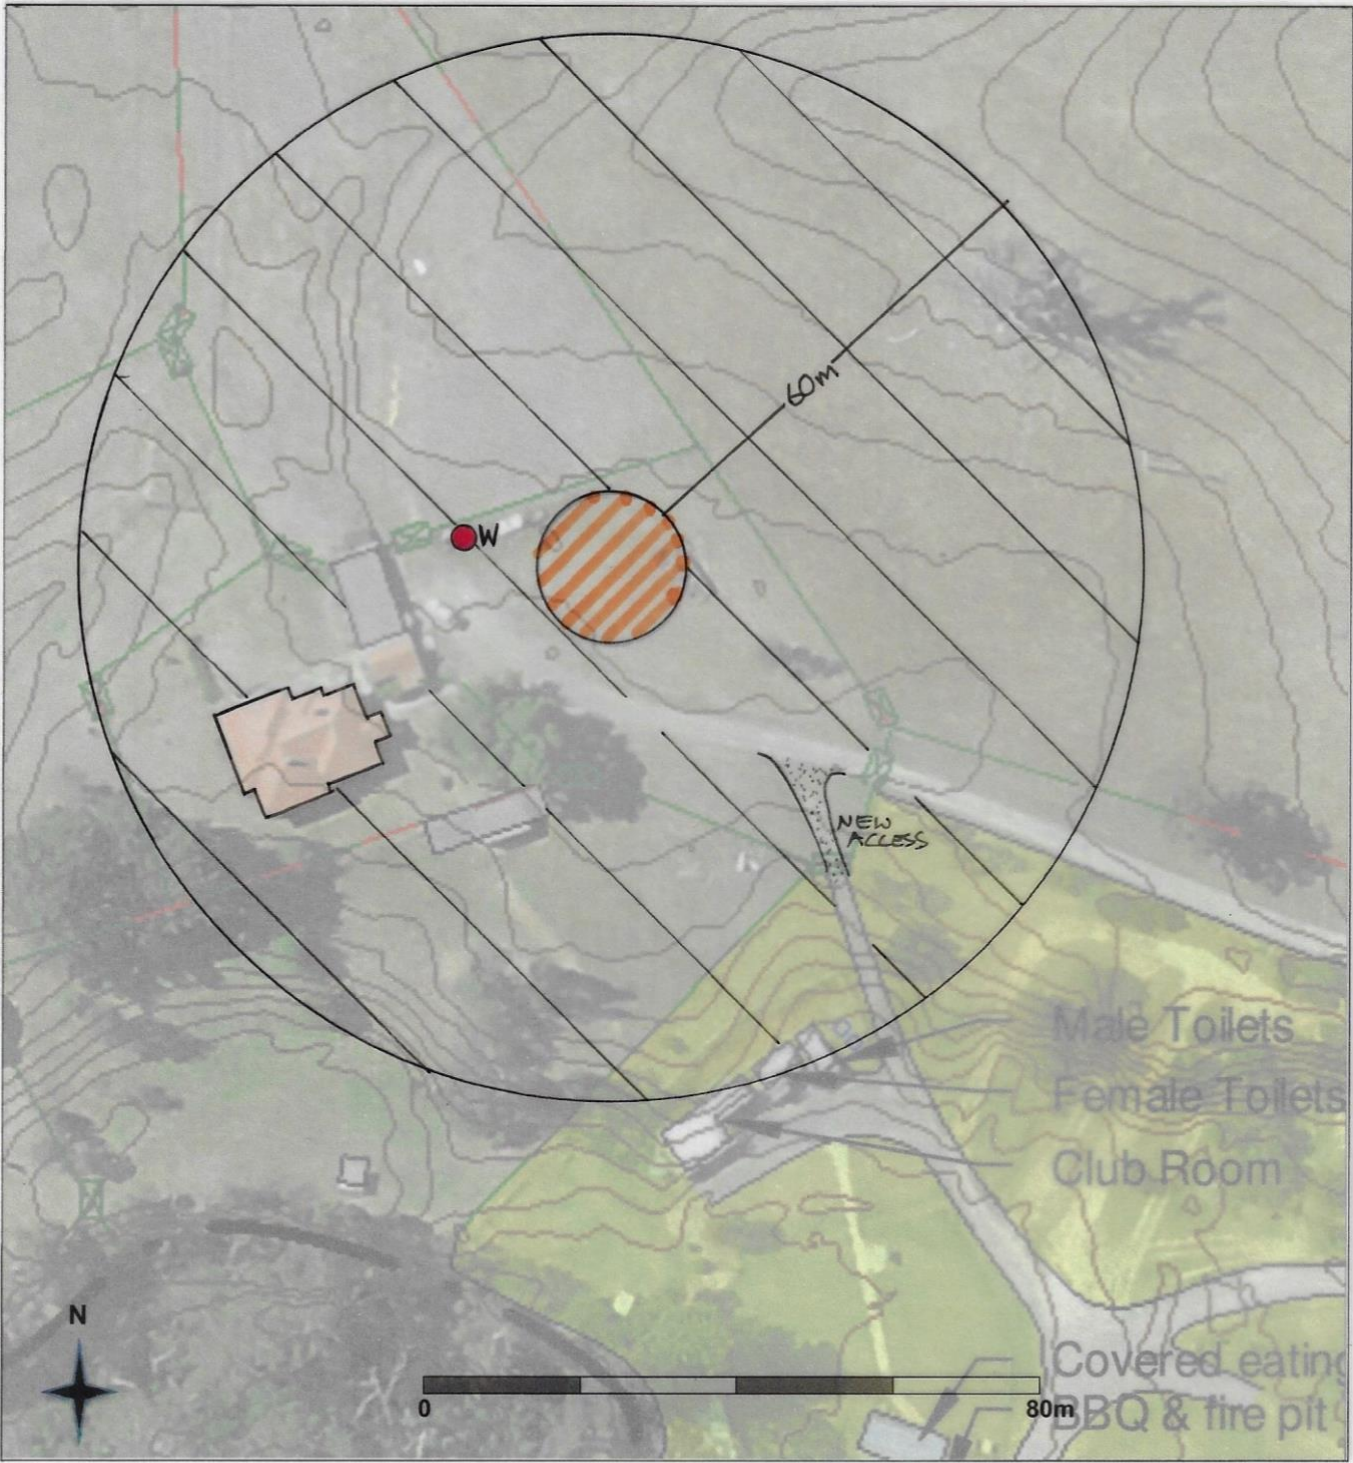
DEFENDABLE SPACE (Table 6 Vegetation management requirements)
Defendable space is provided around the proposed Emergency Assembly Area for a distance of 60m in all directions where vegetation (and other flammable materials) will be maintained in accordance with the following requirements:

WATER SUPPLY (Table 4 Water supply requirements)
A water supply with an effective capacity of **10,000 litres** must be established on the site for firefighting purposes which meets the following requirements:

ACCESS (Table 5 Vehicle access design and construction)
Access to the Emergency assembly Area and CFA water supply outlet must meet the following requirements:

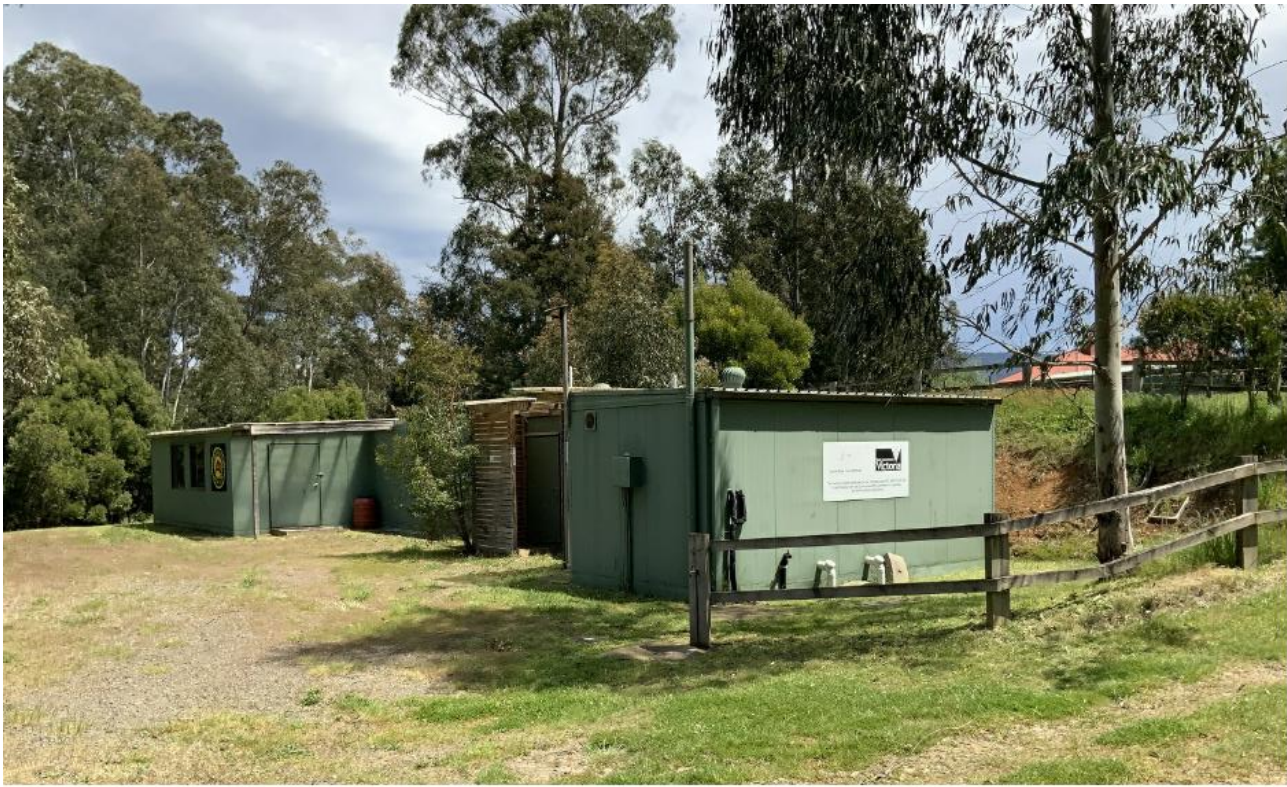
Photo 1 - Toilet/Shower Blocks and Club Meeting room

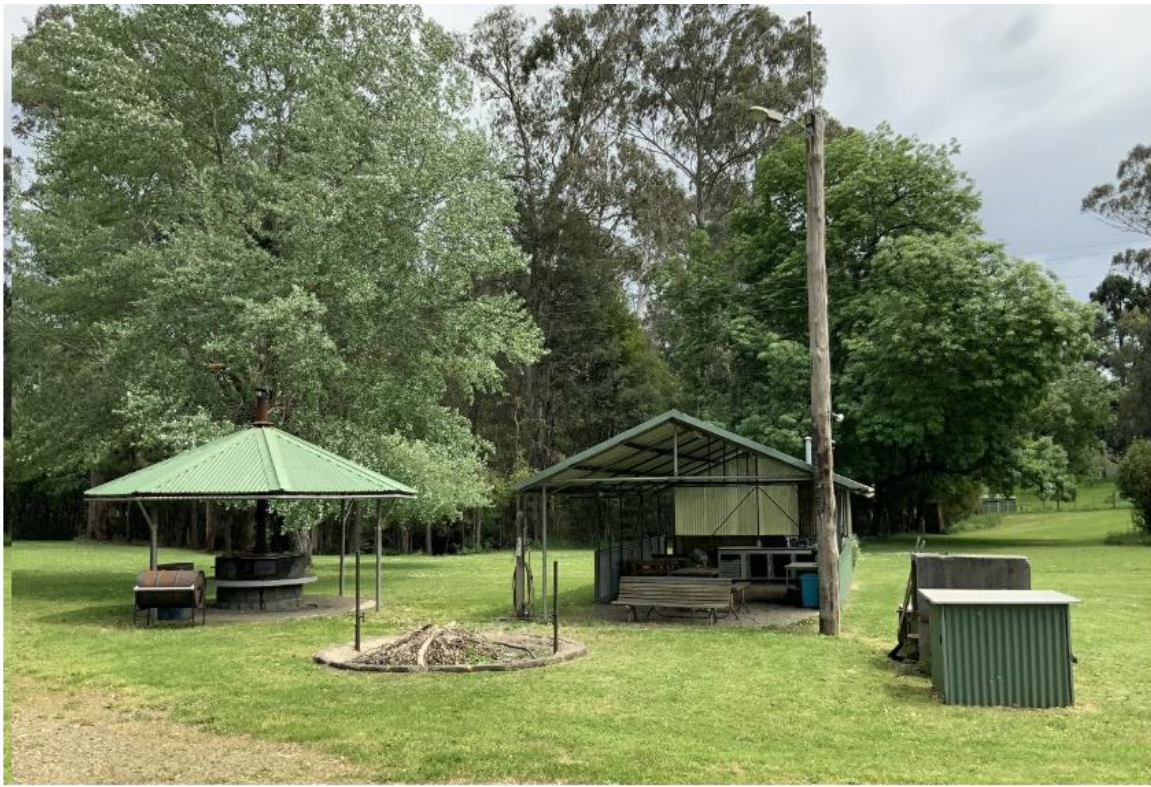
Photo 4 - Coverd eating, cooking fascilities, BBQ and Firepit

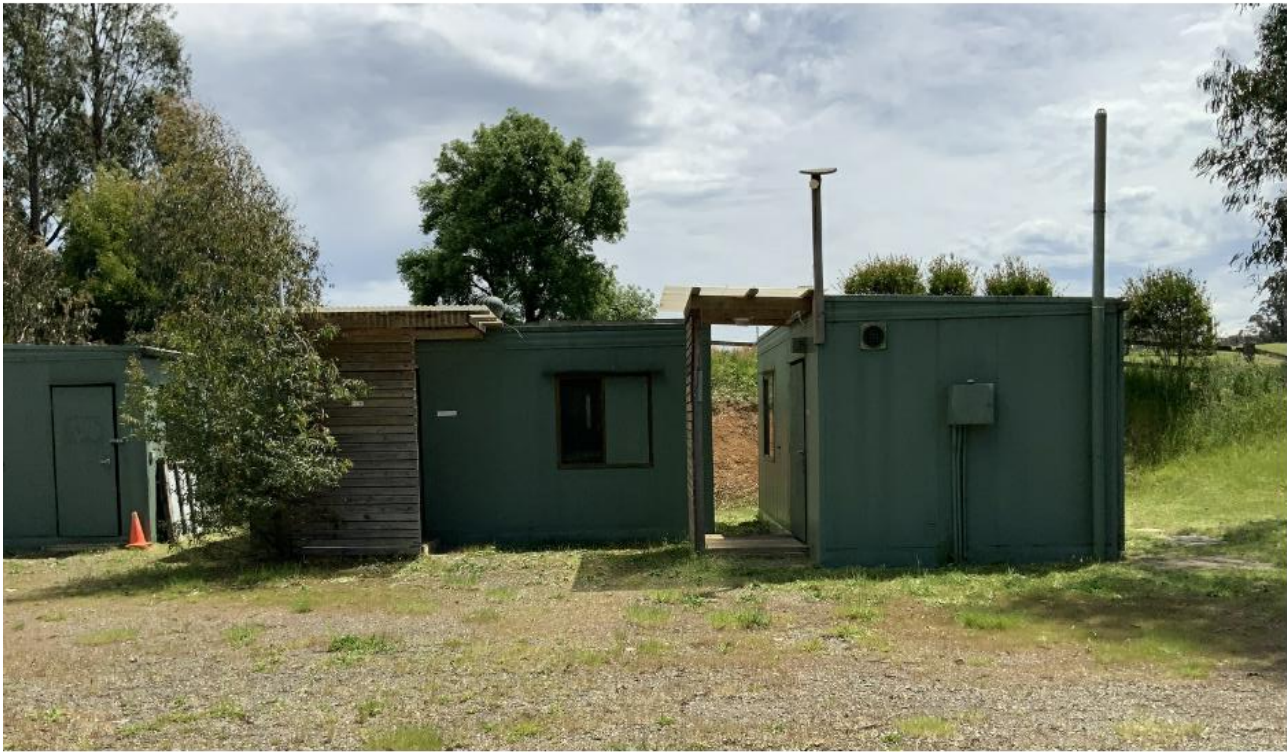
Photo 2 - Male and Female Toilet/Shower Blocks

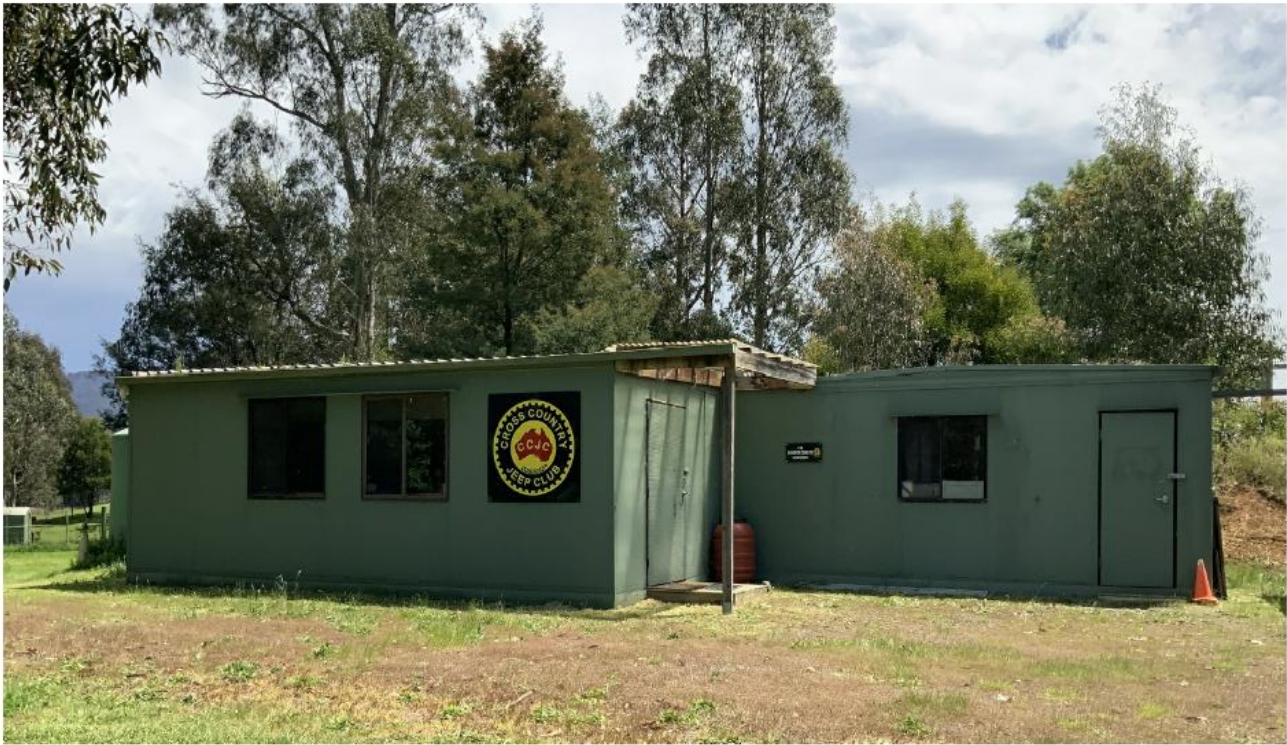
Photo 3 - Club meeting room and Store

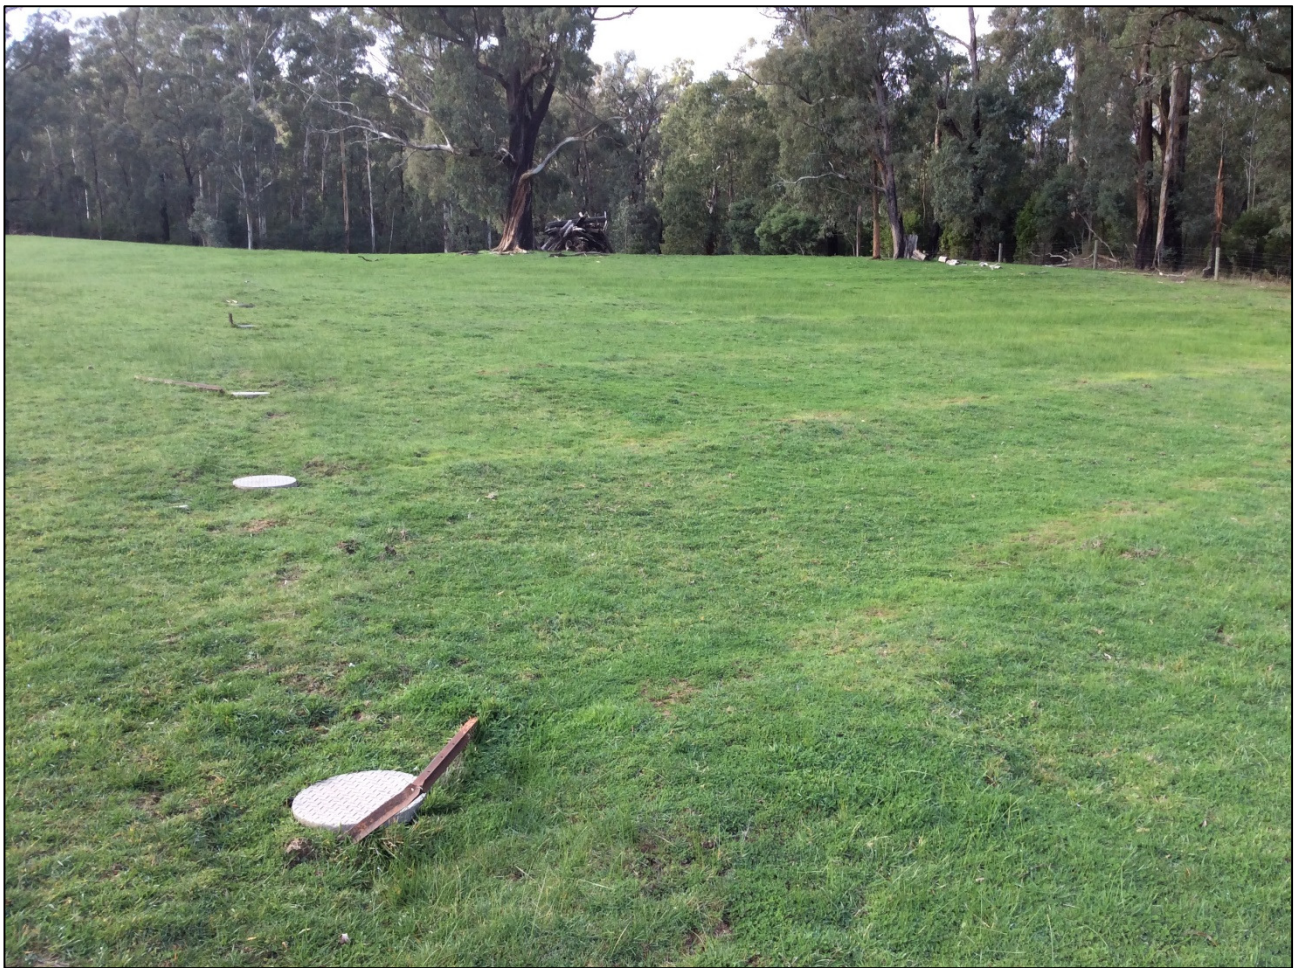
Figure 1: Existing Effluent Disposal Area (LAA) viewed from south east to north west as at 20th July 2019.

The existing effluent disposal area (LAA) is located upslope of the dwelling and campground near the front entry of the property. The area slopes between 7 and 9% in a south east direction and is exposed to winds and sunshine throughout the year as seen in Figure1.

The existing effluent disposal area is vegetated with a mixture of dense pasture grasses including a dense cover of clover as the property is used for grazing livestock as shown in Figure 1 and Appendix C.

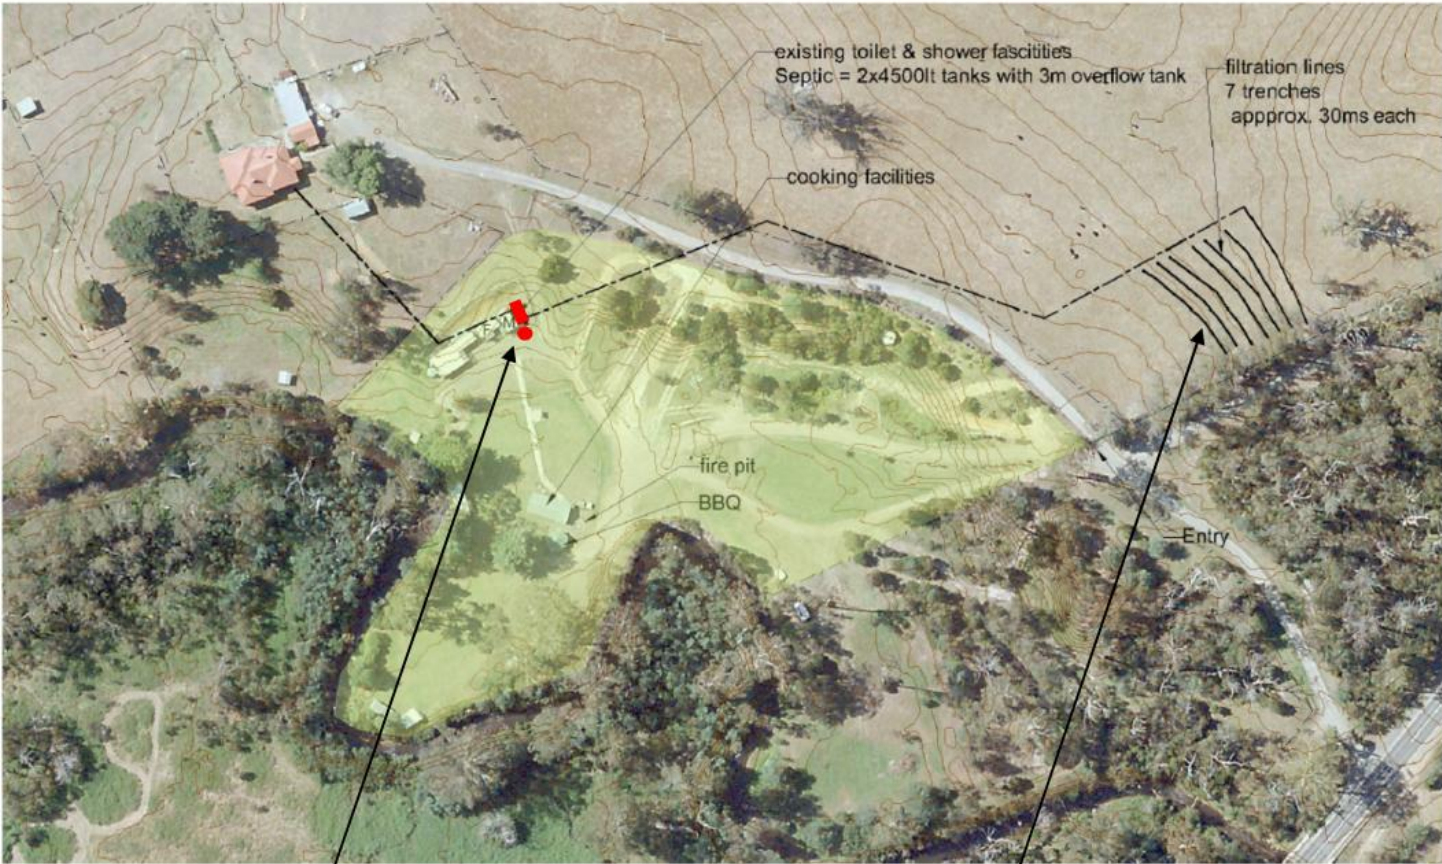
Farm house and Campsite plan - scale 1:1000

Site Plan
Not to Scale

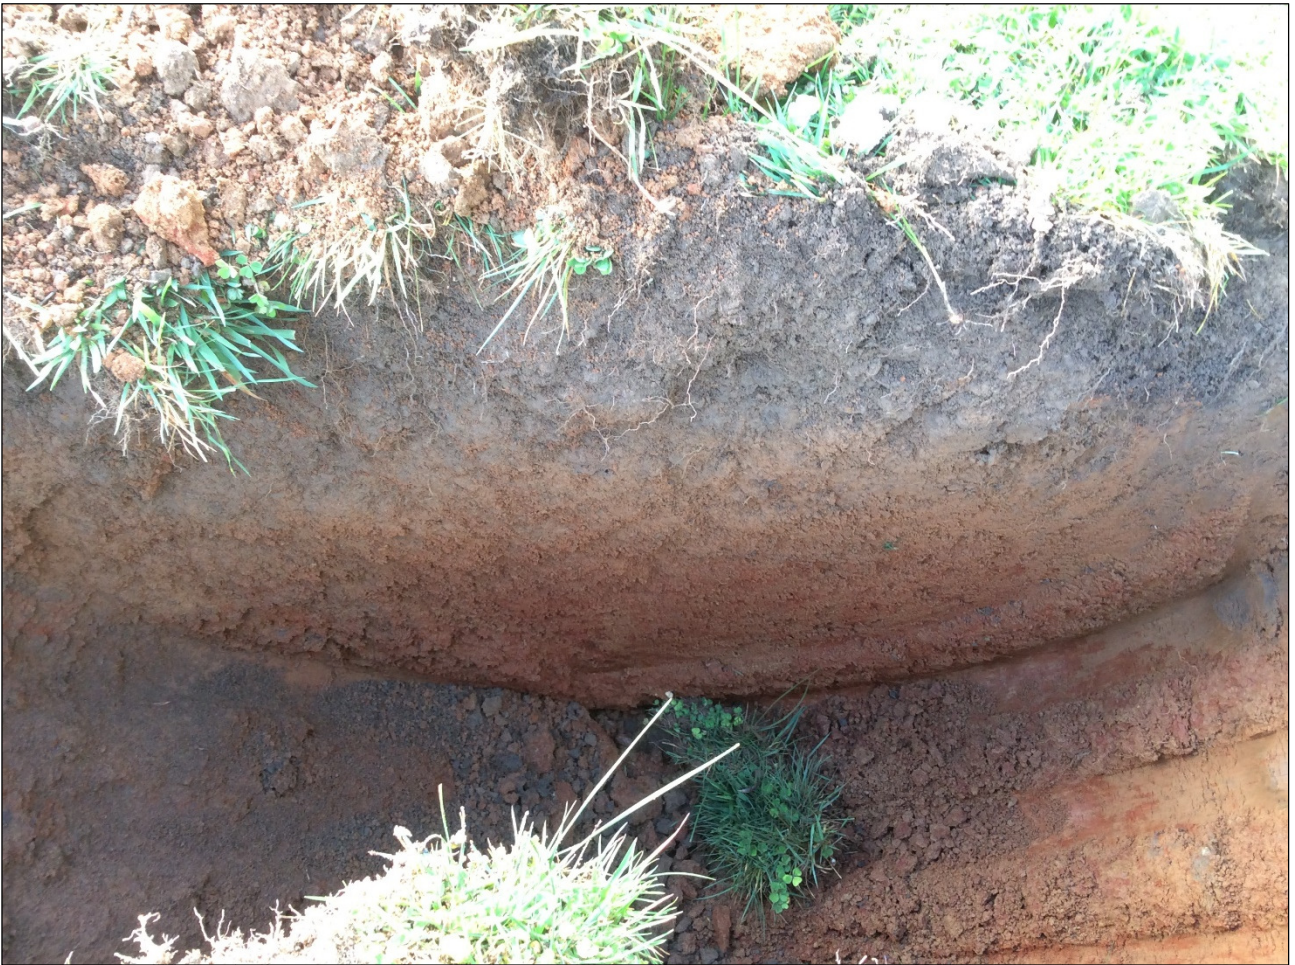
Soil Horizon

- A-horizon; layer of black, sandy silt (loam) with a soil reaction trend of 5.9 pH and electrical conductivity of 0.10 dS/m, to a depth of 140mm
- B₁-horizon; layer of brown, sandy silty clay (clay loam), moderately structured clay with a soil reaction trend of 6.1 pH and electrical conductivity of 0.08 dS/m, between the depths of 140-510mm
- B₂-horizon; layer of red-brown, silty clay, (light clay), with a soil reaction trend of 6.3 pH, electrical conductivity of 0.07 dS/m, between the depths of 510-1200mm.

The soil horizon profile can be seen in Appendix C.

Soil samples were taken from the excavation test pit on 20th July 2019 as seen in Appendix C.

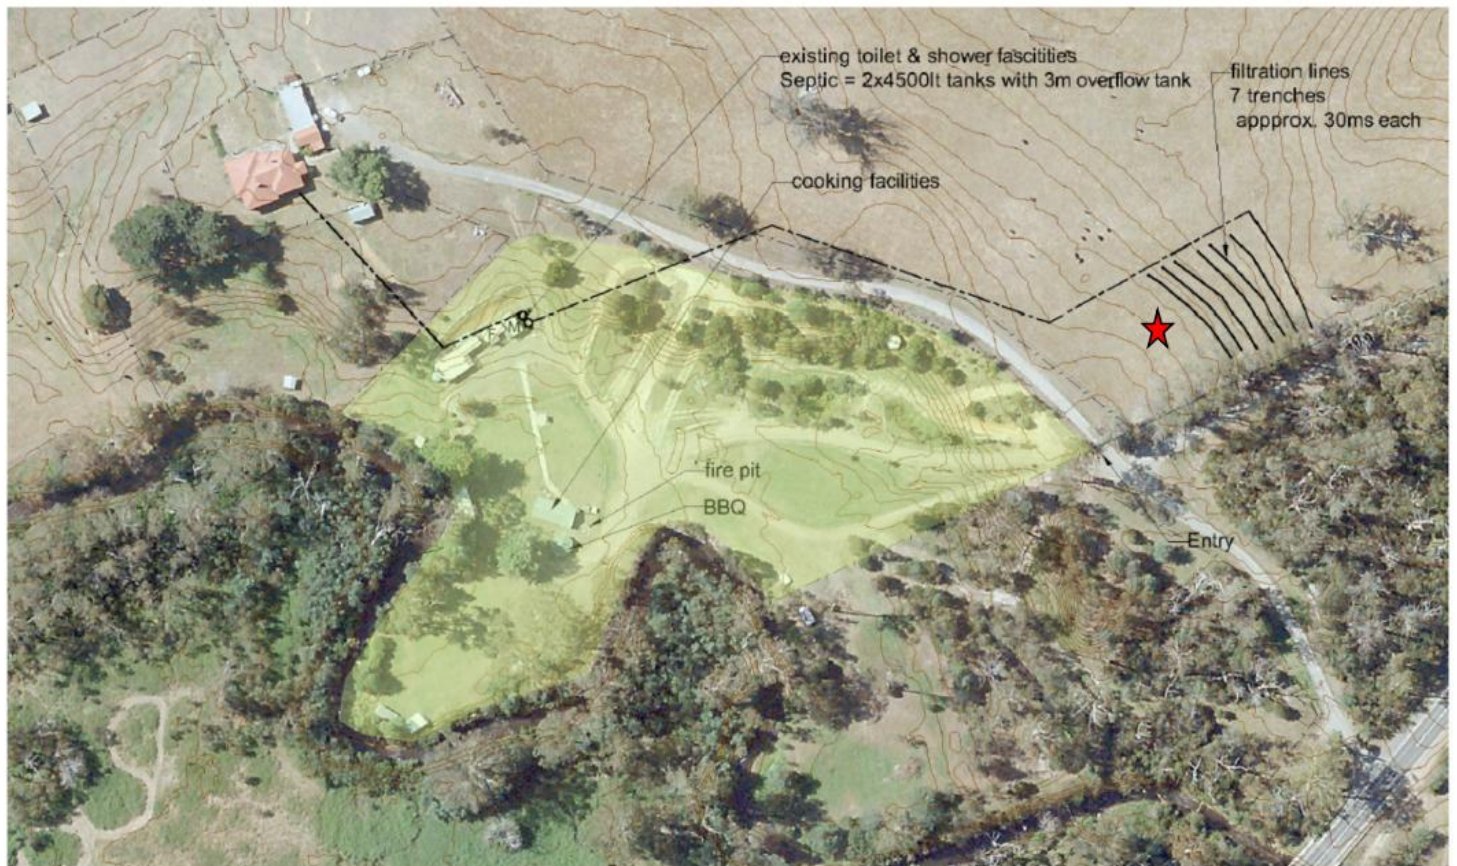
Farm house and Campsite plan - scale 1:1000

Bore hole testing location

GPS Location 37° 30.895' S
145° 40.692' E
