## BREAKAWAY BRIDGE FAQs – JUNE 2023

Breakaway Bridge in Acheron suffered significant damage resulting from the October 2022 Floods, including the loss of the northern bridge abutment and one bridge span.

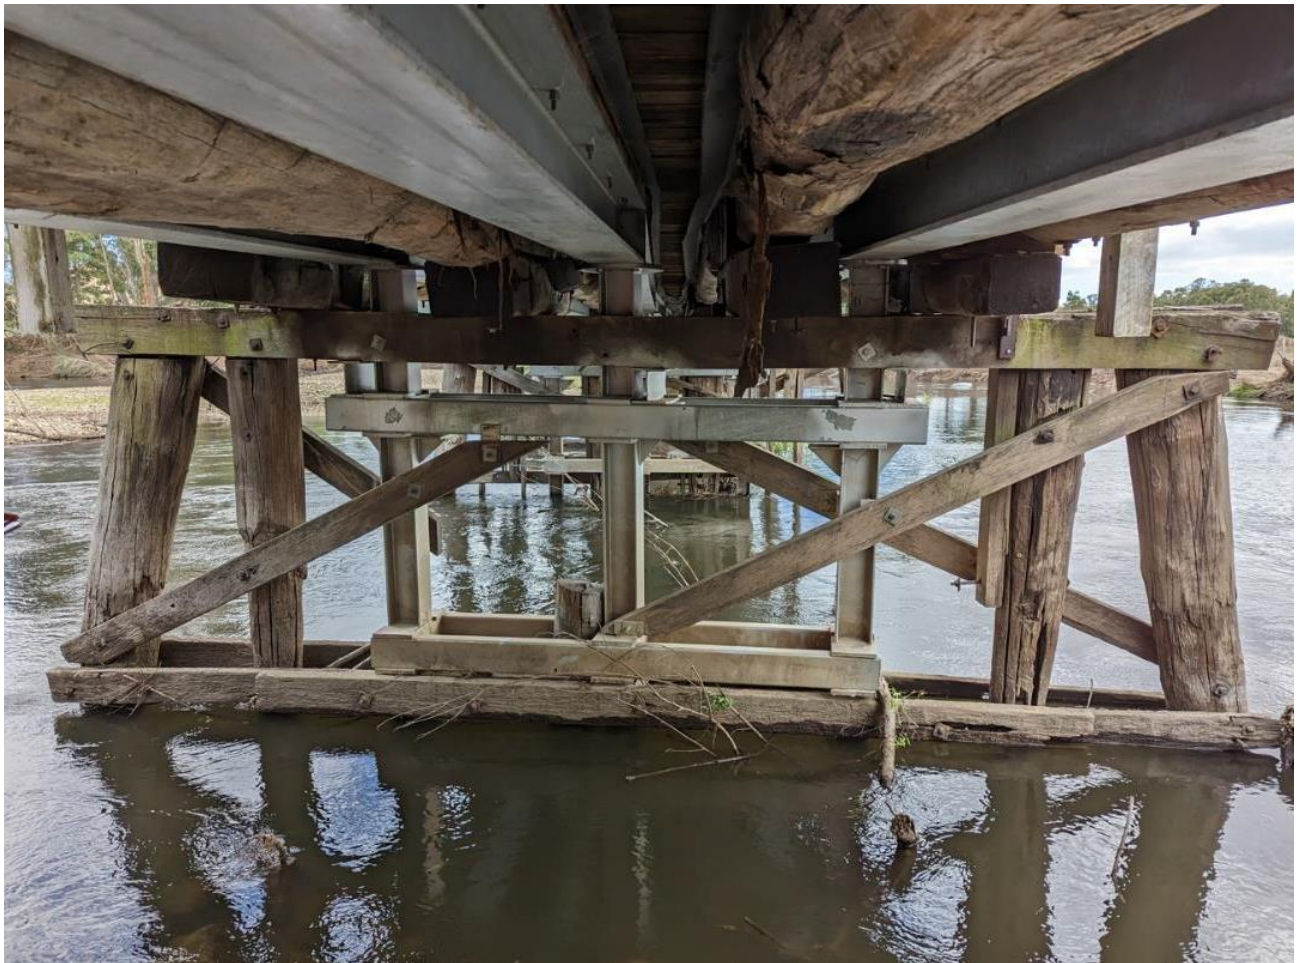
- the steel frame of the bridge is in good condition
- many of the timber pier and truss elements are damaged or in poor condition
- the timber bridge deck is in poor condition
- handrails are in fair condition
- the vertical support of the bridge remains capable of supporting a 20 tonne load limit and existing materials are suitable for repair
- timber elements of the bridge would require refurbishment.

*Photo showing the timber truss and steel frame beneath Breakaway Bridge*
